Docket No. 217 – Development and Management Plan Inspection

Date: November 17, 2005

Location: 115 kV Underground Route

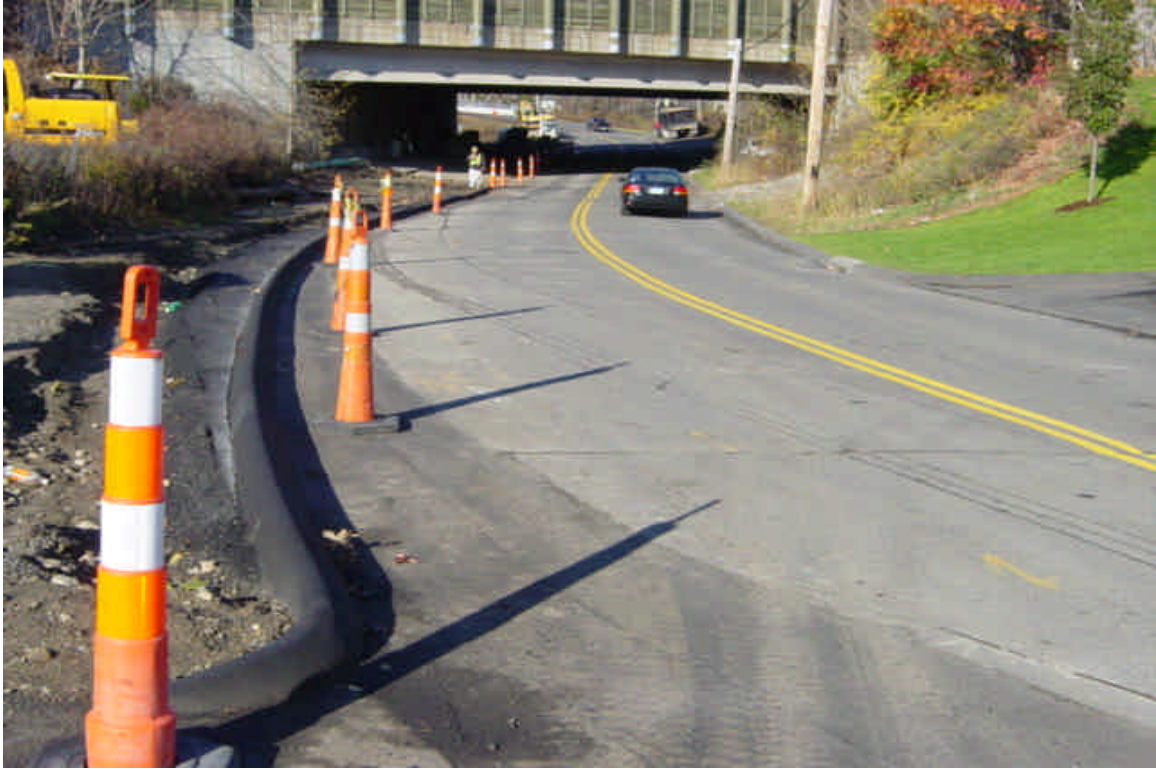
115kV (Broad Street): View of the edge of roadway restoration with installation of curbing following the trenching activities here. Pavers are being put back into place under the overpass. 11/17/05

- Curbing and sidewalk installation was occurring along the roadway here. Restore any remaining areas with seed and mulch. 11/17/05	-None at this time. Trenching activities are complete here. 11/17/05

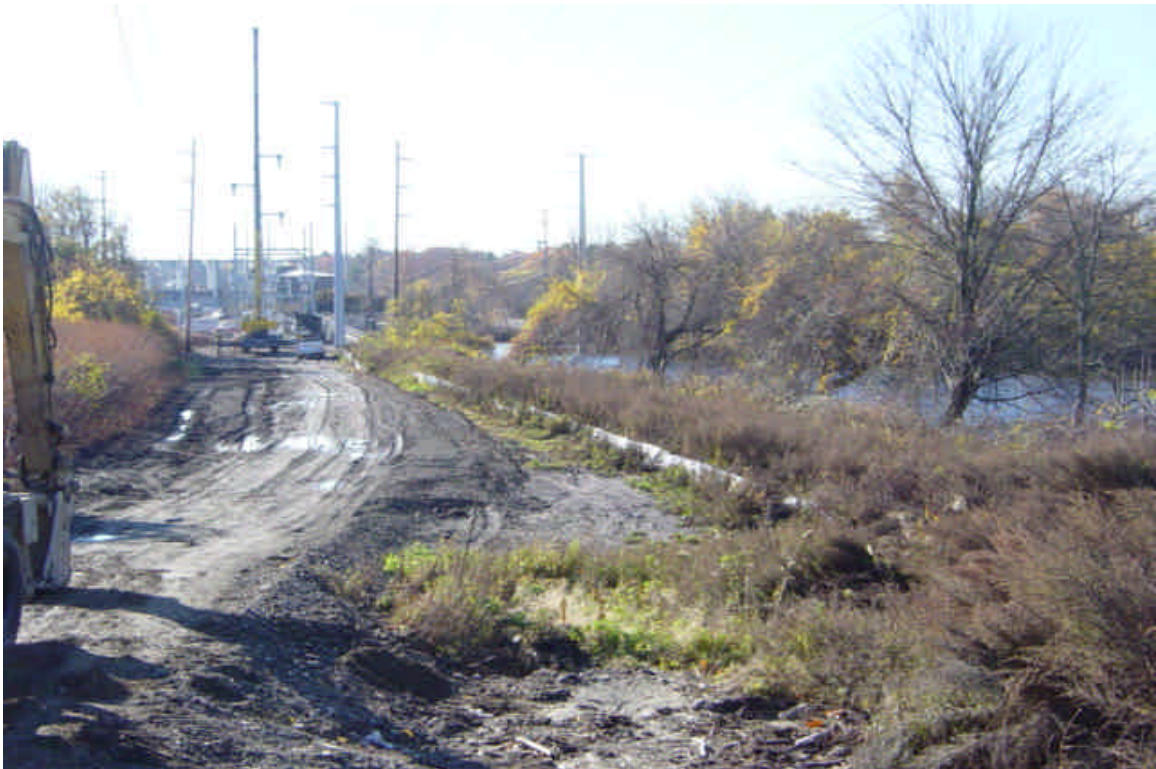
115kV (Broad St. and ROW): View of the ROW with grading ongoing in preparation for the installation of the bike path in this area. 11/17/05

Areas of Inspection	Observation	Recommended Action
Broad Street and ROW, Norwalk	- The silt fence is well installed along most of the ROW and grading in preparation for the construction of the bike path was ongoing. 11/17/05	- Continue to maintain silt fence where needed. 11/17/05

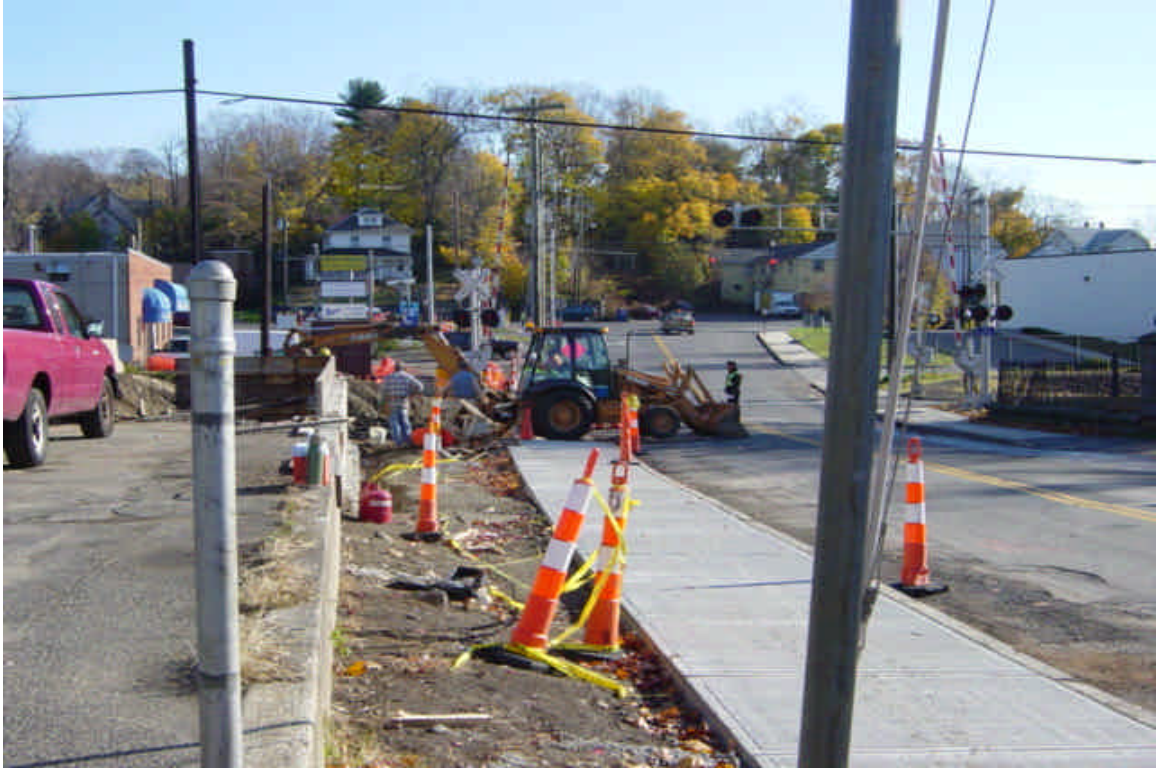
115kV (Railroad Jack and Bore). View of the remaining work in the vicinity of the J&B on Broad St. Sidewalk was being restored and excavation areas were brought to grade. 11/17/05

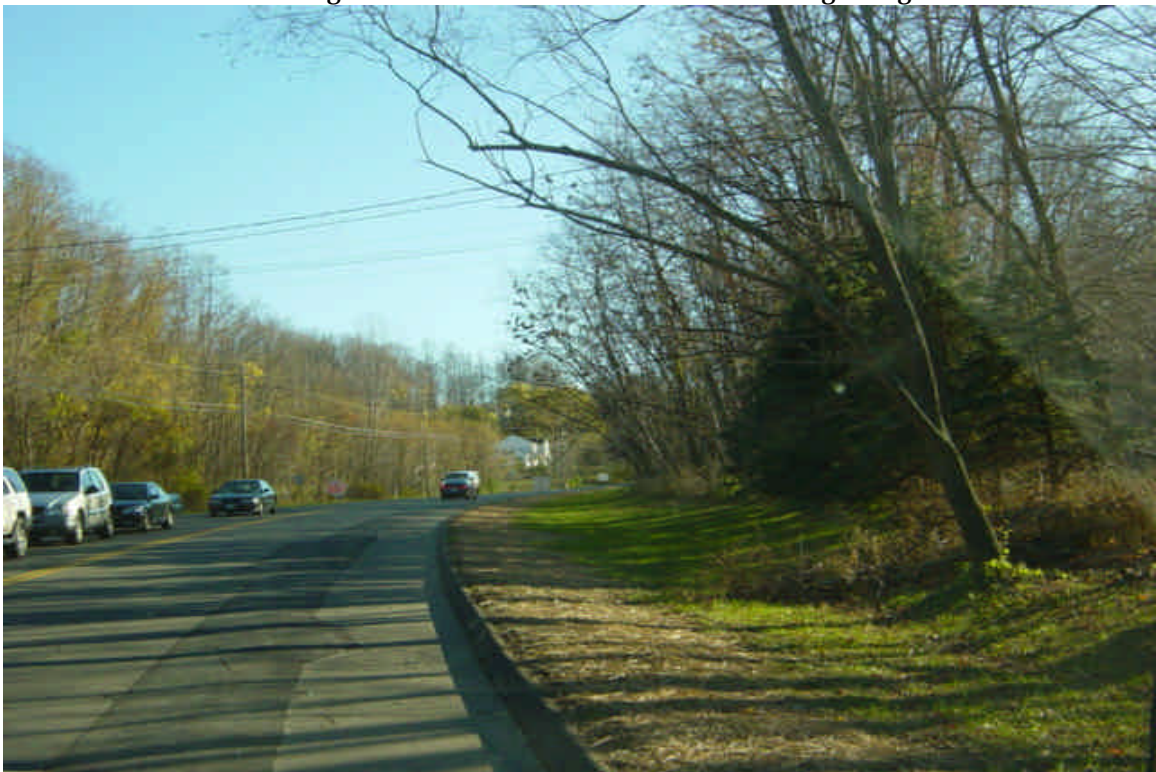
115kV (Rt 58). View of restoration efforts typical along the roadway with seed and straw mulch. 11/17/05

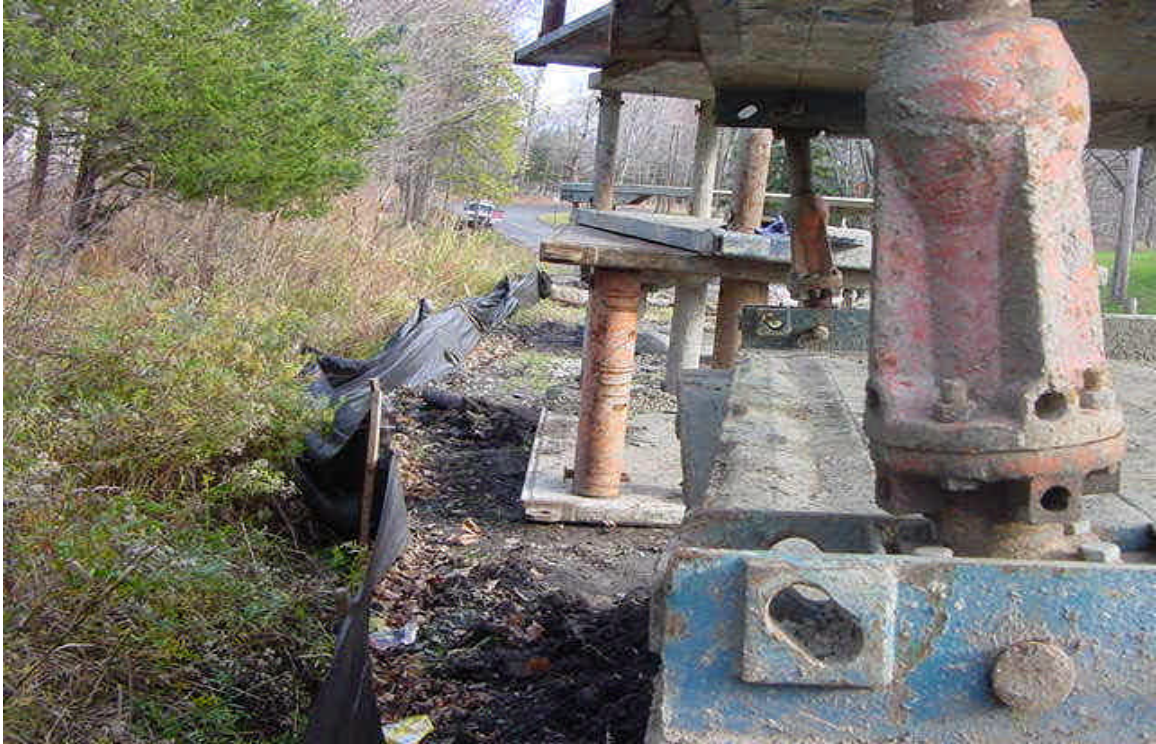
115kV: (Rt. 58) View of the storage yard at Sunset Hill Rd. Silt fence here could use some repair adjacent to the stockpile. (Photo from 11/17/05)

- Silt fence should be retained at the stream and at the Putnam Park storage area near the pond as the yard is still being used occasionally. 10/27-11/17/05	- None at this time. 11/17/05
	-The Sunset Hill Rd. storage area could use some silt fence maintenance. 11/10-11/17/05	- Pull trench boxes back from the fence and repair near the stockpile. 11/17/05
Rt. 107 (Lonetown Rd)	-The roadway and adjacent work areas are largely stabilized. 11/17/05	- None at this time 11/17/05
	-Silt fence has been removed from along the road near the Redding Country Club as the area appears stabilized. 11/17/05	-In general, monitor road work and make sure no soil is stockpiled. Restore the roadside if equipment causes disturbance during this phase. 10/19-11/17/05

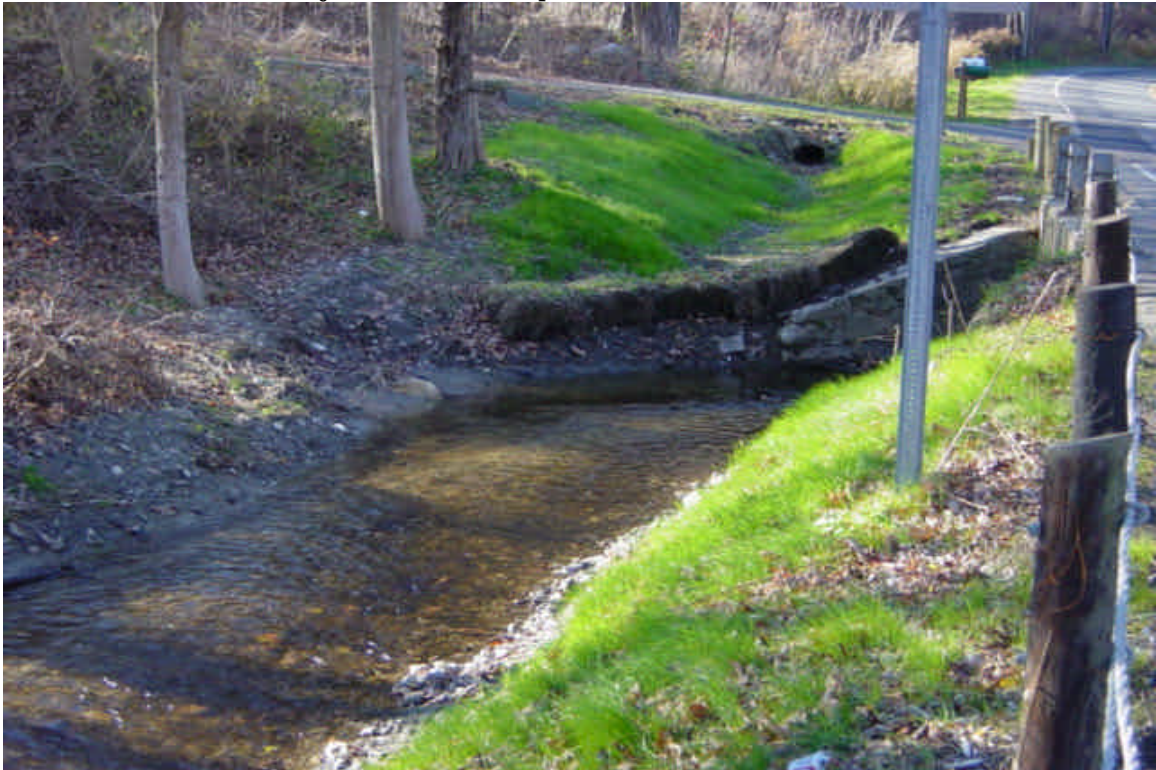
115kV: (Rt. 58/Sara's Way). The slopes adjacent to the stream have experienced good establishment of grass and silt fence was removed as a result. Haybale check dams remain across the outlet swale to the stream. 11/17/05

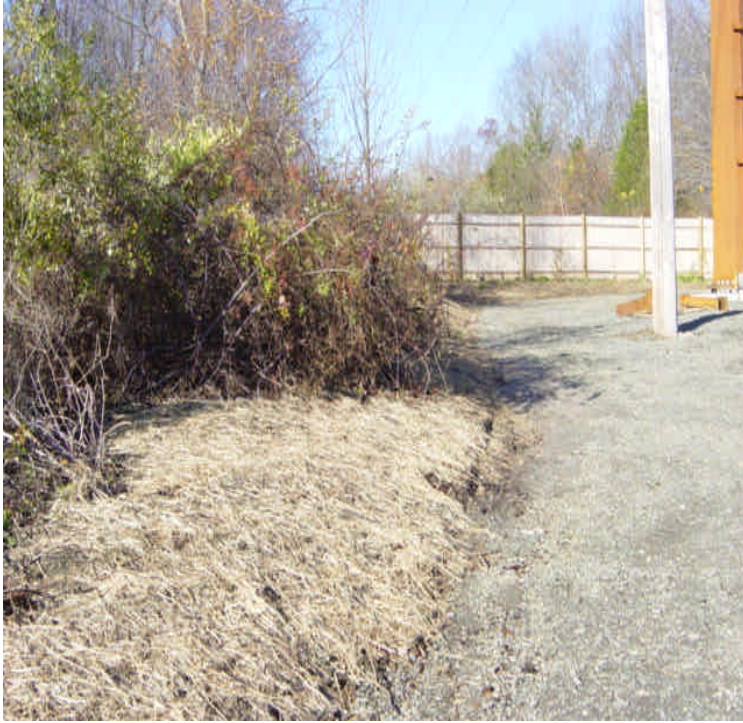
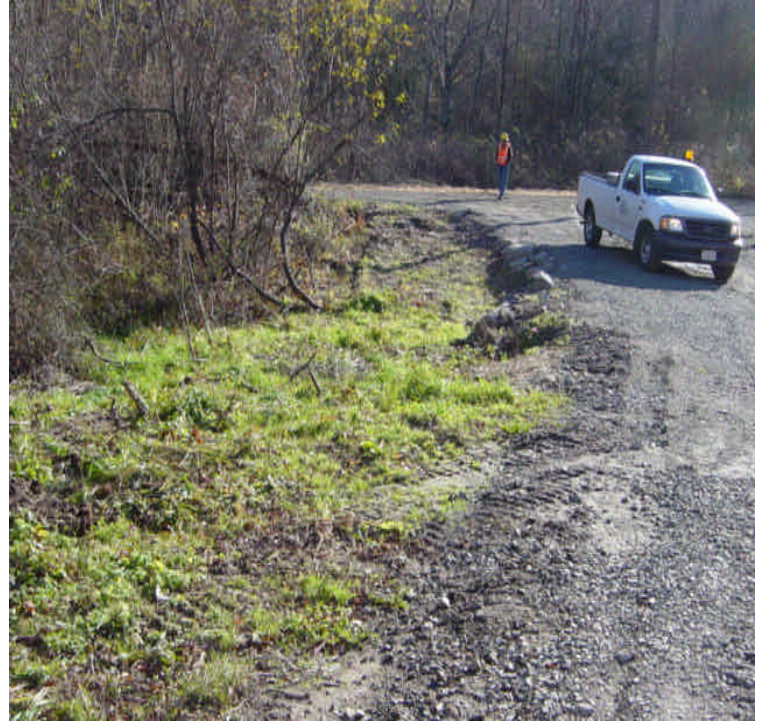
Hoyts Hill Riser Transition Structure (Off Rt. 58)	- Erosion controls have been removed from most areas but the sides of the access drive are well mulched or revegetated. 11/17/05	- The area appears to be mostly stable at this time. 11/17/05

115kV (Hoyts Hill Transition Structure): Both photos show either side of the access drive leading to the transition structure. The areas have either been mulched or revegetation and silt fence was removed. (11/17/05)

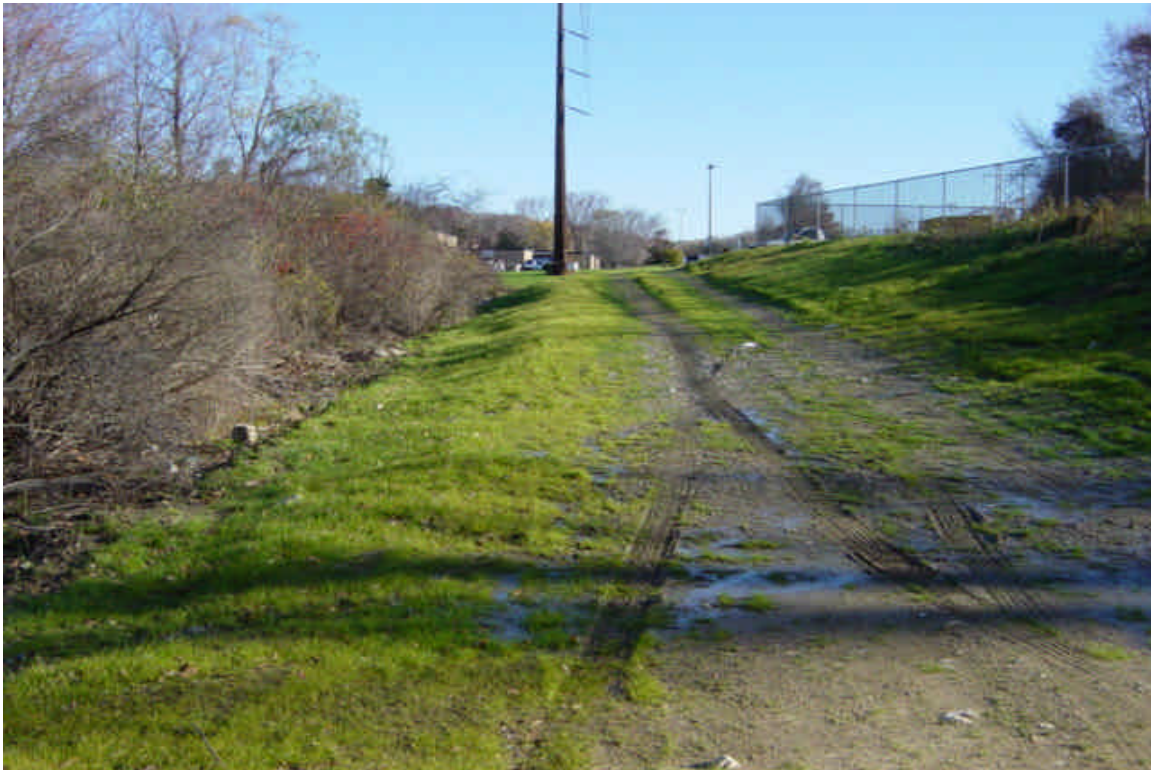
115kV (Bethel Ed. Park): Photo shows the northern portion of the ROW where the grass is growing in well and silt fence has been removed as a result. 11/17/05
